Manhole Inspection Summary

Manhole # S37YY_015MH

Insp Date: **12/28/06 12:16 PM**

Location Address: **501 GORSUCH AVE**

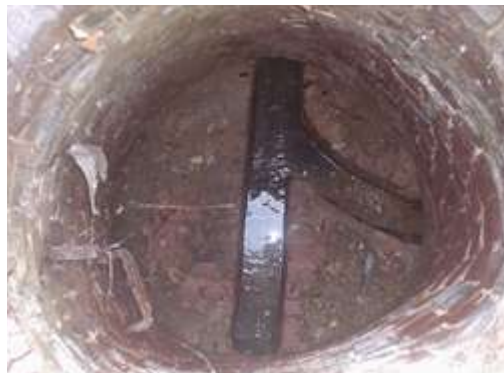
Top View

Corroded and missing steps. Evidence of surcharge - Bench debris. Channel debris.

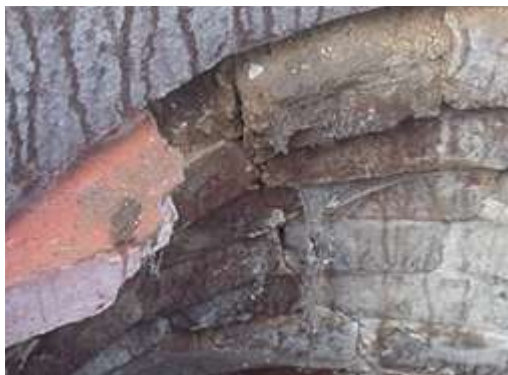
Defect

Adjustment and Corbel deterioration and infiltration.

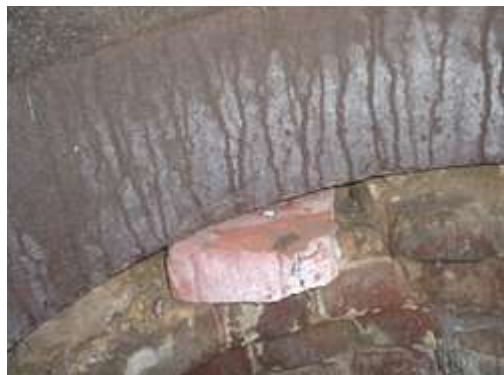
Defect

Adjustment deterioration, loose brick and infiltration.

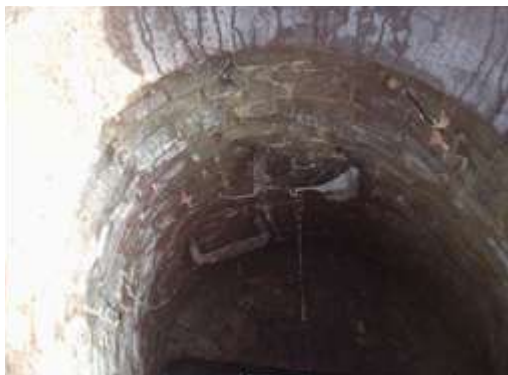
Defect

Adjustment deterioration and infiltration. Corbel infiltration.

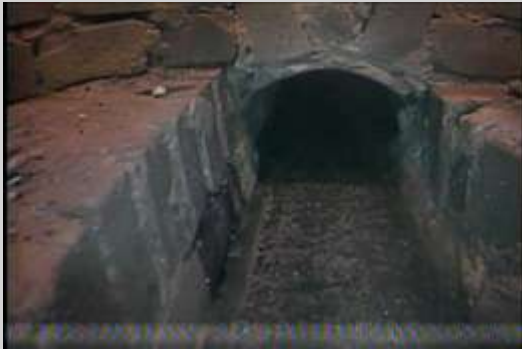
8 in. Circular Gravity Sewer Pipe Out @ 12 O'Clock

Deposits: ☐ None ☒ **Mud** ☐ Sludge ☒ **Debris** ☐ Grease

Silt Depth: **0.5** (in.) Deposits Extent: **Light**

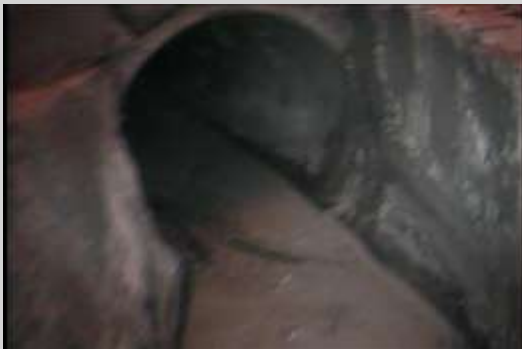
8 in. Circular Gravity Sewer Pipe In @ 3 O'Clock

Deposits: ☐ None ☒ **Mud** ☐ Sludge ☒ **Debris** ☐ Grease

Silt Depth: **0.5** (in.) Deposits Extent: **Light**

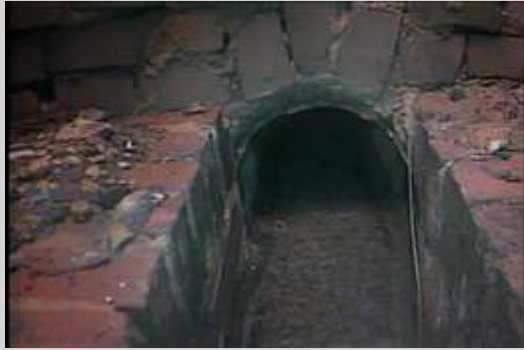
Pipe In @ 6 O'Clock

Deposits: ☐ None ☒ **Mud** ☐ Sludge ☒ **Debris** ☐ Grease

Deposits Extent: **Light**

Infiltration: **Evidence**
